M/V J. W. WESTCOTT II in drydock following salvage. Note tires attached to the rail. Photo taken on November 8, 2001.

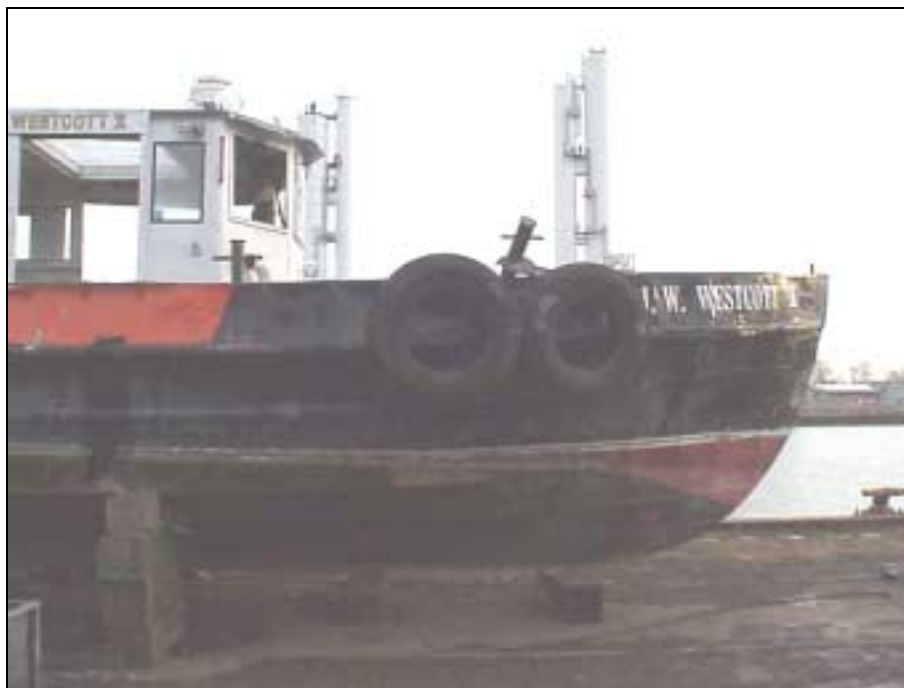
Starboard side forward of J. W. WESTCOTT II. There are two tires shown in this view. The third tire was removed and lost during salvage. There are two more tires on the starboard side, identical to the port side. Photo taken on November 8, 2001.
